Subject: September 2018 Clean Water Act Compliance Inspection

CWA COMPLIANCE EVALUATION INSPECTION REPORT
U.S. ENVIRONMENTAL PROTECTION AGENCY, REGION 5

Purpose: Compliance Evaluation Inspection

Date of Inspection: September 6, 2018

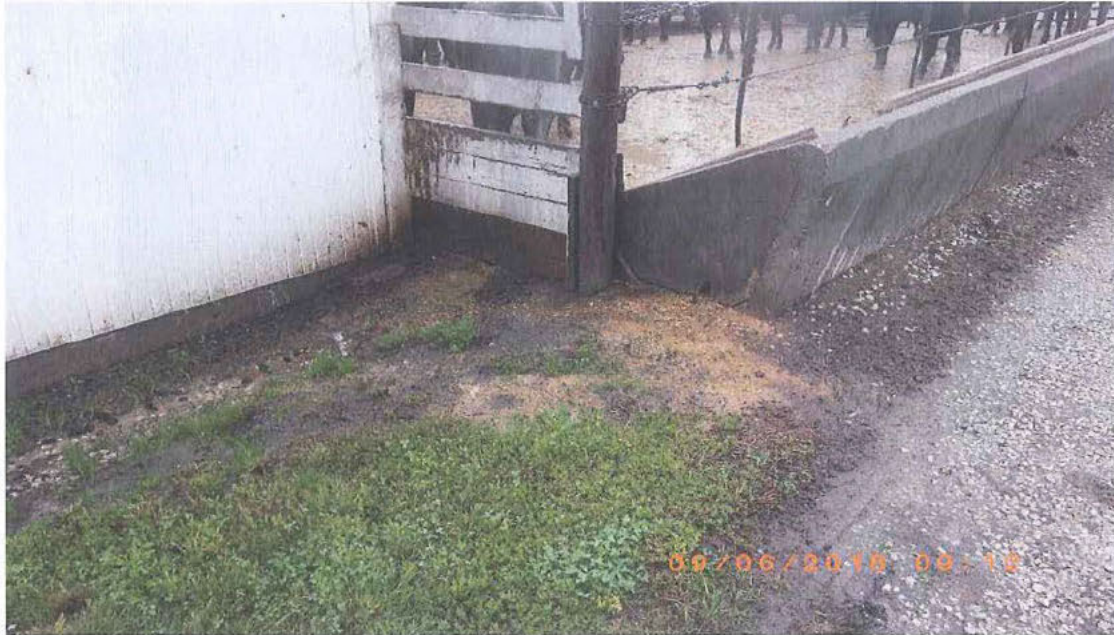
4: RIMG0373

The inspectors began the inspection at the satellite facility north of Illinois 92. The inspection began at the southeast corner of the feedlot (photo 3). The Inspectors walked north along the east side of the feedlot. The Inspectors observed an area at the northeast corner of the feedlot where runoff from the feedlot was contained by wood boards. A small amount of runoff was observed to be seeping from beneath the boards. Additionally, a hole in the east end of the feed bunk allowed stormwater to drain from the feed bunk. The runoff from the feedlot and bunker did not appear to leave the site (photos 4-5).

- 1) Feedlot runoff and feed bunk runoff was observed to be not contained at the satellite facility.
- 2) Woody vegetation was observed growing around the manure holding pond on the northwest corner of the facility.
- 3) No depth gauges were observed in manure holding ponds.

Description: A small amount of manure and feed was observed on the ground at the Northeast end of the satellite feedlot outside the perimeter of feedlot. Stormwater drainage runs east along a small barn. The manure and feed observed did not extend beyond the area of the photo. The final disposition of the runoff of this area could not be verified during the inspection because no clear overland flow of water was apparent.

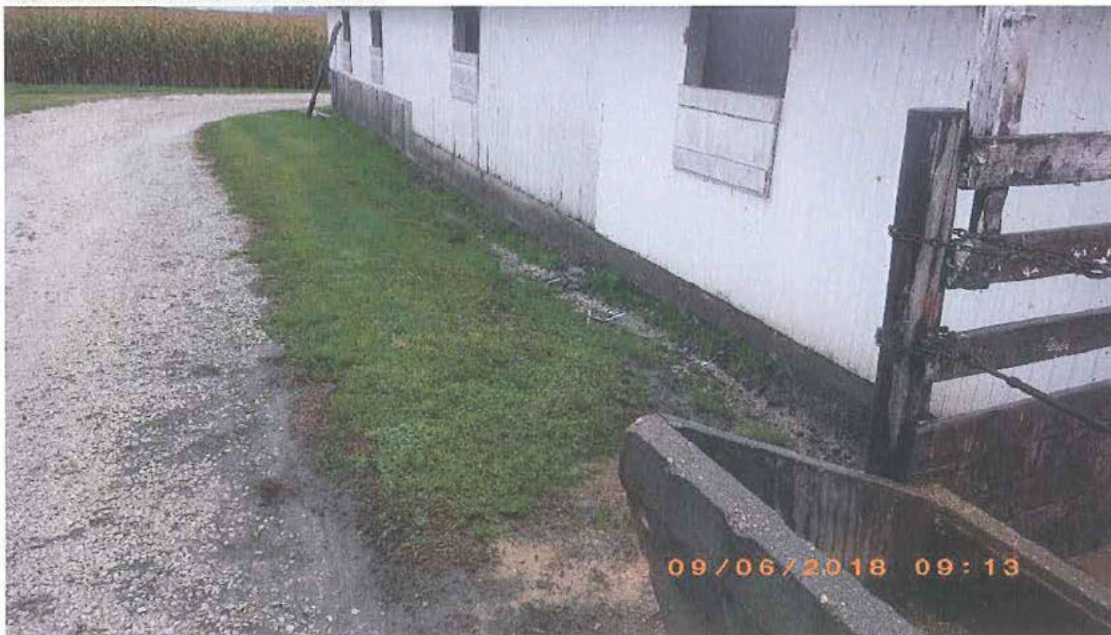
5: RIMG0374

Description: The runoff pathway along the north end of the small barn flows east.

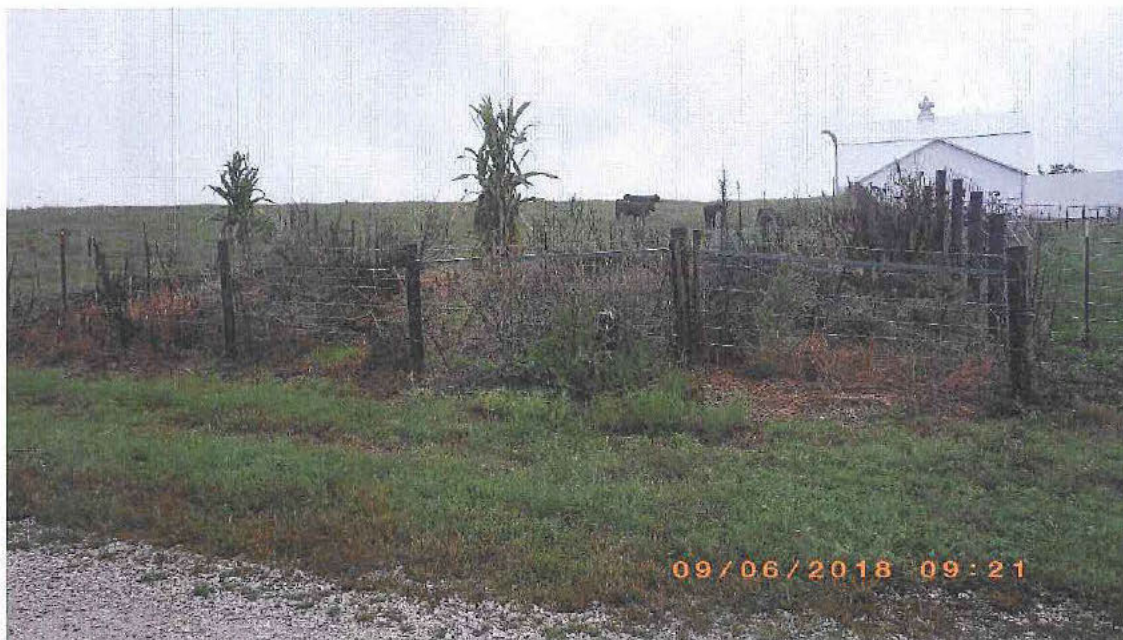
6: RIMG0375

The Inspectors walked west along the north side of the feedlot then south along the west side. The inspectors then walked west and observed a second feedlot at the satellite facility. The inspectors walked west along the south side a fenced pasture west of the second feedlot to an access road. The inspectors then walked north along the west side of the pasture to observe the west side of the second feedlot. The inspectors observed a bermed area in the corner of the pasture through which a pipe was protruding. No flow was observed to be coming from the pipe (photo 6).

Description: A pipe was located at the southwest end of a cattle pasture. The pipe was not flowing during the inspection.

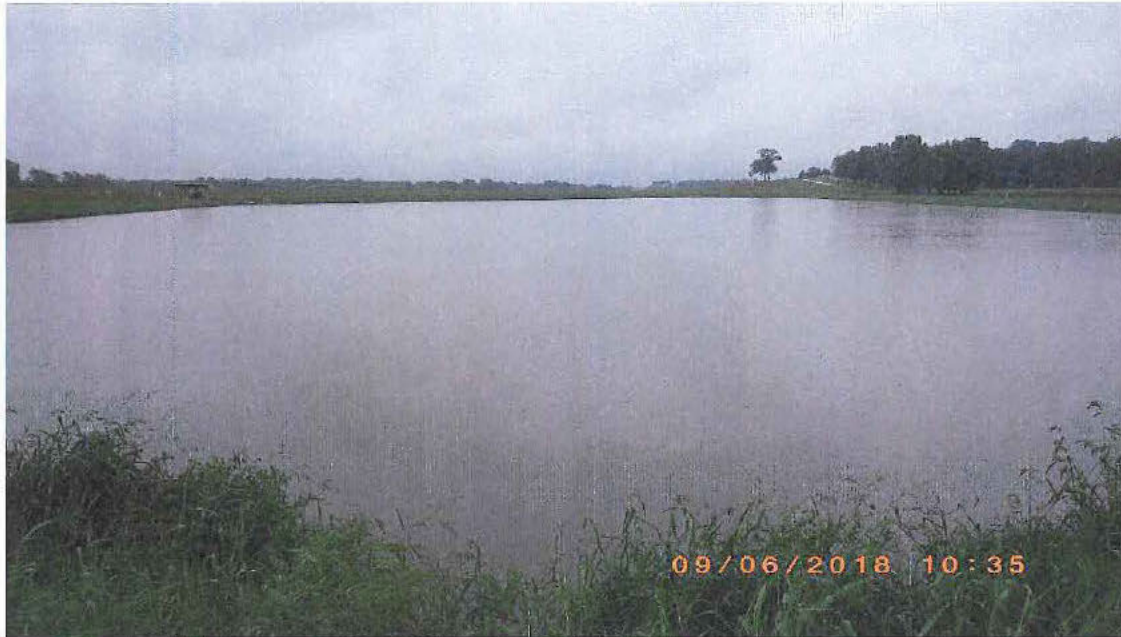
18: RIMG0387

Description: The large waste storage facility was located at the south end of the [REDACTED] Beef site. The inspectors did not observe an operational level marker in the large waste storage facility.

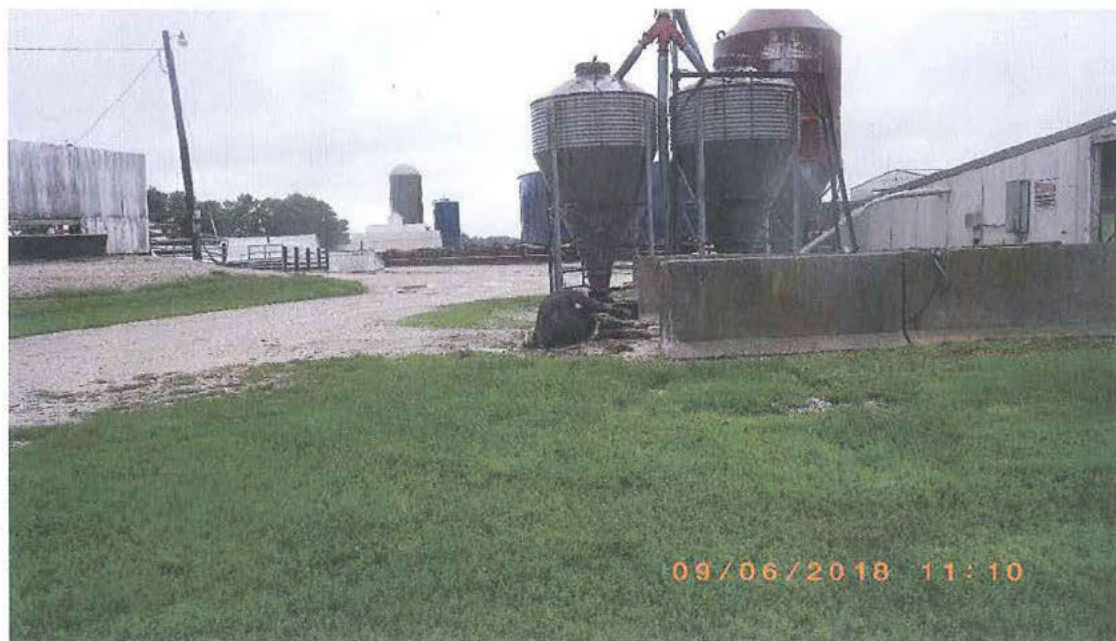
21: RIMG0390

Description: A dead cow was observed at the east end of the barn the was south of the northwest waste storage facility.

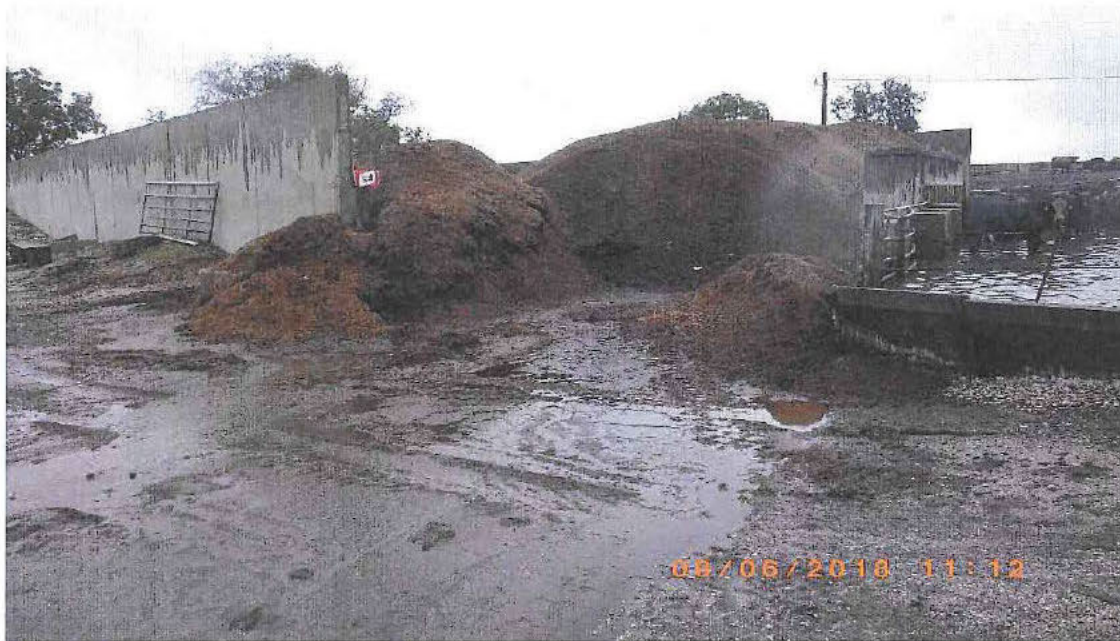
22: RIMG0391

Description: The solid manure holding area is sloped to the southwest.

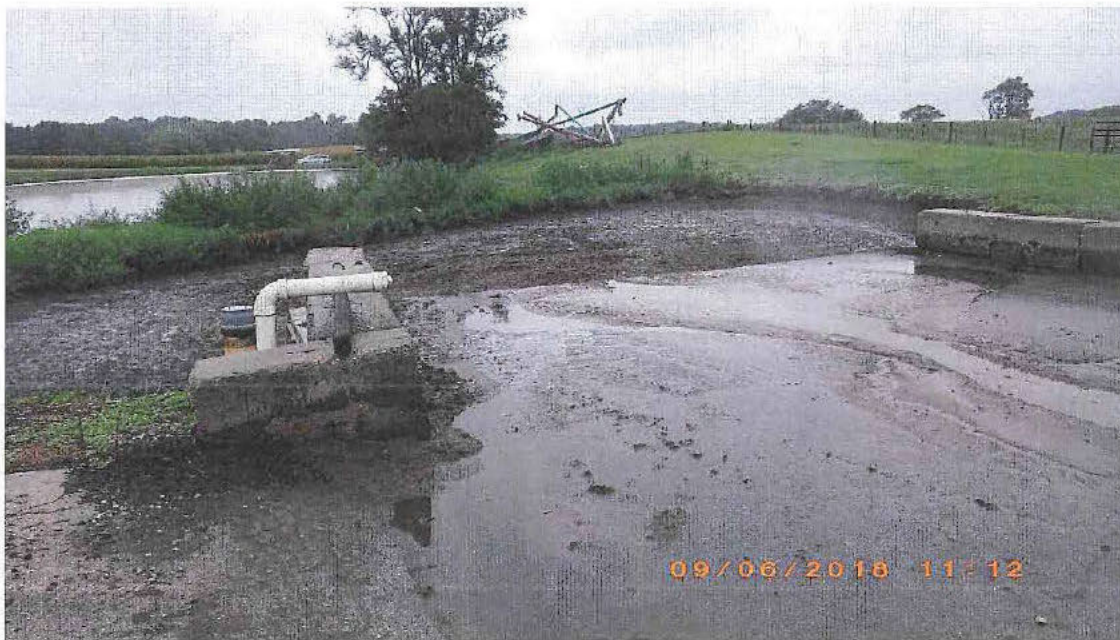
23: RIMG0392

Description: A solids settling pond was located at the northeast end of the northwest waste storage facility. The solids settling pond connects to the northwest waste storage facility via an overflow ditch on the northwest end of the solids settling pond.
